Test report

BTI number: 26692-A2A/2019

Investigation of the long-term behaviour of **Whisper® NBO-40-A3** noise barrier wall types using time lapse test based on EN 14389-1:2015, EN 14389-2:2015 and EN 60721-3-4:1995 for 50 simulated years.

Sealed Air Verpackungen GmbH

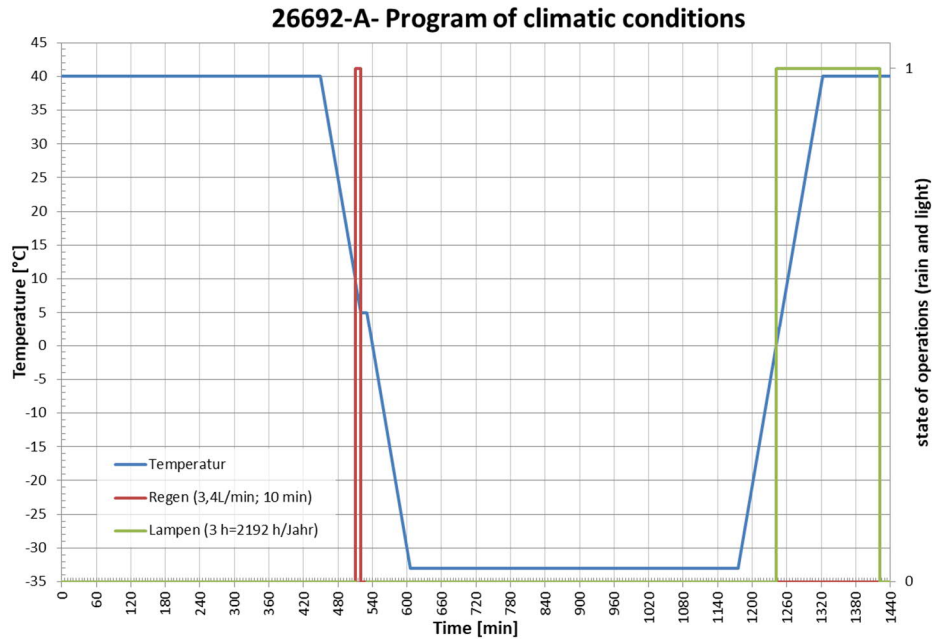
Fig. 2: Program of the climatic conditions in the climate chamber

The conditions selected in agreement with the client were chosen as follows (see Fig. 2):

- Climate class 4K2 (-33 to +40 °C)
- An older internal control test with material from a noise barrier wall built 30 years ago resulted in good agreement with the assumption of approx. 100 days of ageing in the climate chamber equivalent to 50 years for wood-chip concrete.

- To achieve a more homogeneous temperature distribution in the test material, the cycle was defined as one frost/defrost cycle per 24 h. A holding time of 9.5 h at -33 °C and at +40 °C per cycle, or twice that per theoretical year, results from the temperature change rate of 0.5 K/min.

- The lighting is switched on for a total of 3 hours during the warm-up phase (corresponds to approx. 2000 hours of sunlight per year). The duration was distributed over the first 10 simulated years such that 6 equal blocks resulted, each separated from each other by 0.5 h (3-6 1h blocks) in order to avoid a concentrated temperature input and related surface temperature increases.

- Sprinkling with salt water (1%) to simulate an increased salt concentration along streets and realized over a time period of 10 minutes (spreading over the surface) using spray bars (~34 L/m²).

- The sprinkling is done during the cooling-off phase. This represents one of the worst-case scenarios, since, due to the amount of liquid in combination with the time of application (no time for evaporation) and the falling temperature, increased frost stress is to be expected.

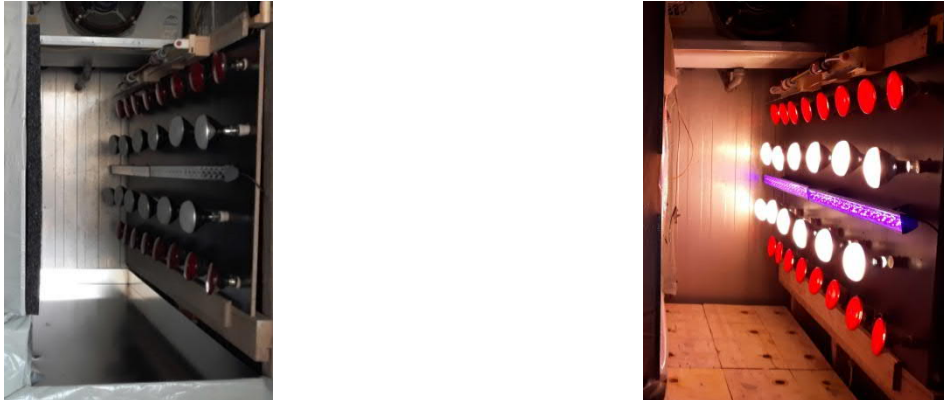
Fig. 4: View into the test chamber (left image) and onto the light panel in the switched-on condition (without collection pans and test elements; right image).

The test chamber consists of a light panel, as shown in Fig. 3 and Fig. 4, made of daylight lamps (Osram Ultra Vitalux300), a UV bar in the middle, and infrared lamps (Philipps IR lamps, 175W) at the top and bottom. This panel was positioned with a clearance of ~60 cm relative to the surface of the test body. Two spray bars for sprinkling were installed above the light panel, and set such that nearly the entire surface of the test body is moistened. To protect the lamps, a plate is mounted under the spray bar, which should prevent drops from reaching the lamps and destroying them.

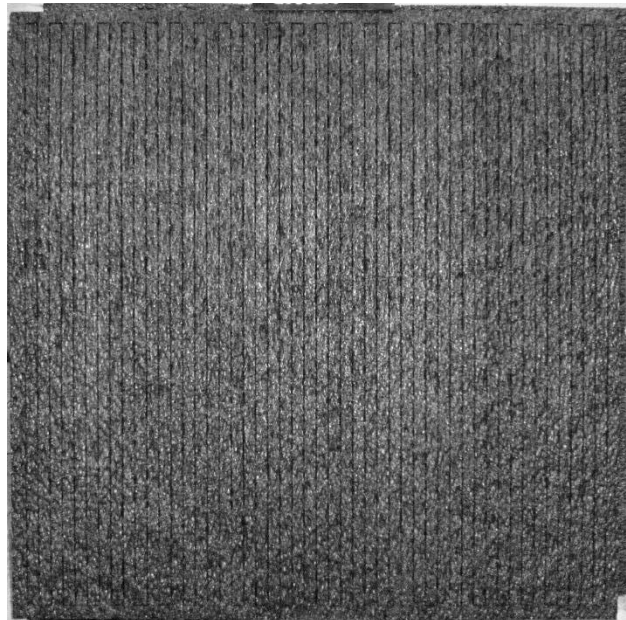
The milled Whisper noise barrier element weighs 1.22 kg. The milling trajectories are spaced 1 cm apart and have a web approx. 1.5 cm wide along the edge. See Fig. 5.

Fig. 5: Initial state of the milled Whisper® NBO-40-A3 absorber element

As a result of the surface treatment (addition of milling trajectories), small plastic fibres have remained in the opened hollow spaces, some of which have been washed out during the course of the test. Due to the light irradiation not being completely homogeneous, as well as the irradiation all at once (1 x 3 h), the element surface overheated and was therefore replaced with a new element weighing 1.23 kg after a small change to the airflow and the switch-on times of the lamps (6 x 0.5 h). See Tab. 4 and Tab. 5.

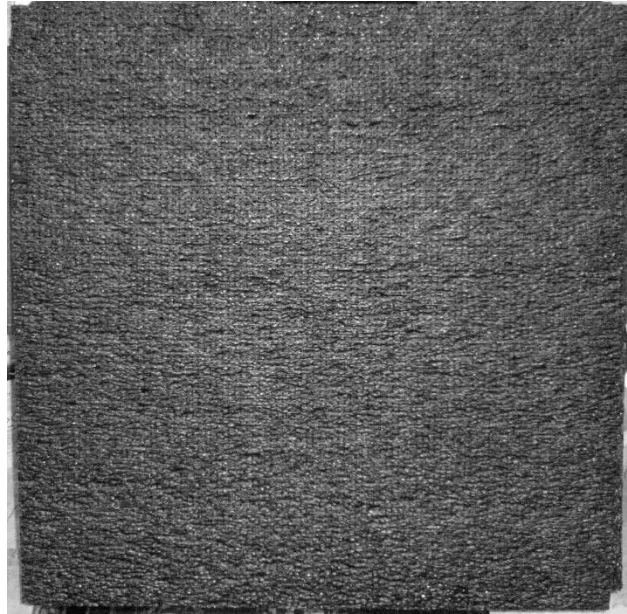
The perforated Whisper noise barrier element weighs 1.25 kg. It has 4 mm boreholes in a 10 x 10 mm grid pattern. See Fig. 6.

Fig. 6: Initial state of the perforated Whisper® NBO-40-A3 absorber element

Due to the light irradiation not being completely homogeneous, as well as the irradiation all at once (1 x 3 h), the element surface overheated and was therefore replaced with a new element weighing 1.22 kg after a small change to the airflow and the switch-on times of the lamps (6 x 0.5 h). See Tab. 4 and Tab. 5.

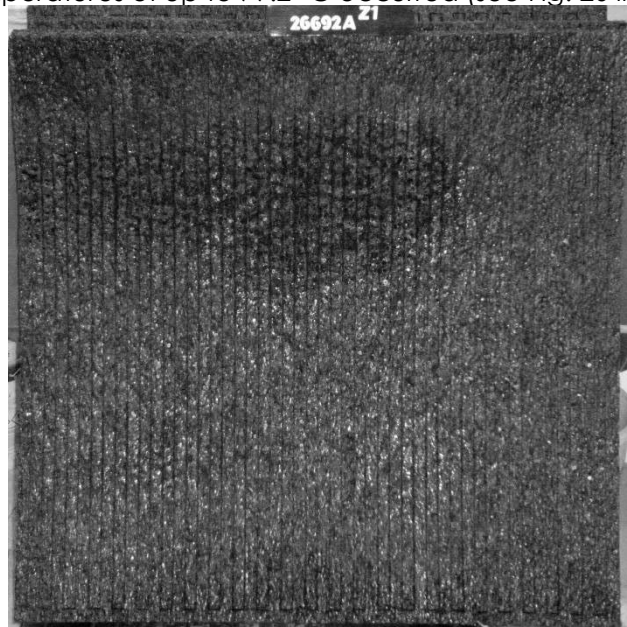
The milled Whisper element shows signs of overheating (upper third) due to the light conditions and air circulation not being completely homogeneous, and was therefore replaced with a new element after consulting with the client. The element has gained 0.8 kg in moisture/salt. 0.6 kg of the absorber in the form of wood-chip concrete chips/fragments fell into the collection pan. See also Fig. 7, as well as Tab. 4 and Tab. 5. The temperature profile for the original element for the simulated years 0-10 is shown in Fig. 20 in the attachment. According to the thermocouple, positioned near the surface of the Whisper element, temperatures of up to 79.2 °C occurred (see Fig. 20 in the attachment).

Fig. 7: Condition of the old, milled Whisper® NBO-40-A3 absorber element after 10 theoretical years with clear signs of overheating in the top third

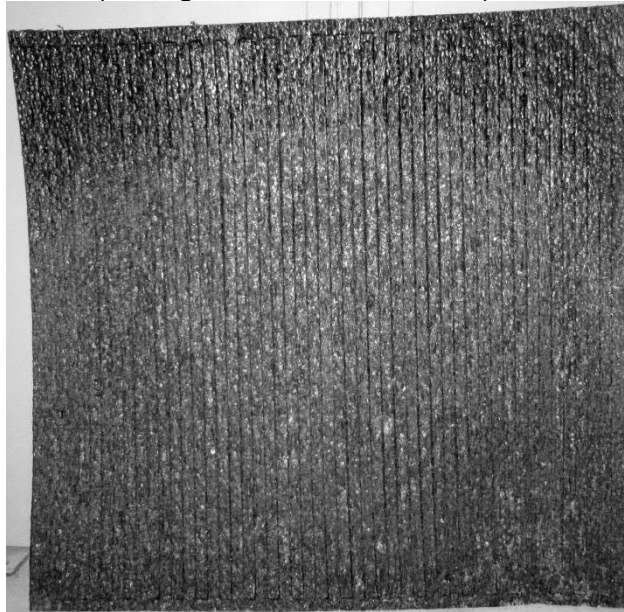
The newly inserted element was deformed due to the variation in thermal stress after 10 theoretical years. Especially in the lower area, there are signs of salt residue left behind during evaporation. The element has gained 0.8 kg in moisture/salt. See also Fig. 8, as well as Tab. 4 and Tab. 5. The temperature profile for the new element for the simulated years 0-10 is shown in Fig. 21 in the attachment. According to the thermocouple (positioned in the hot spot; near the surface, approx.

1/3 of the way from the top and approx. 1/3 from the left edge), temperatures of up to 84.8 °C occurred in the Whisper element (see Fig. 21 in the attachment).

Fig. 8: Condition of the new, milled Whisper® NBO-40-A3 absorber element after 10 theoretical years with the airflow slightly modified compared to the upper element (Fig. 7).

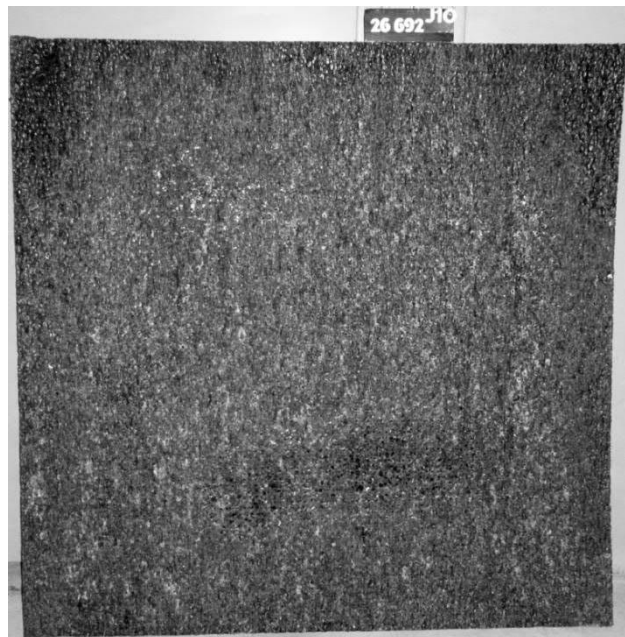
The perforated Whisper element shows signs of overheating (lower third) due to the light conditions and air circulation not being completely homogeneous and was therefore replaced with a new element after consulting with the client. The element has gained 0.5 kg in moisture/salt. See also Fig. 9, as well as Tab. 4 and Tab. 5. The temperature profile for the original element for the simulated years 0-10 is shown in Fig. 20 in the attachment. According to the thermocouple, positioned near the surface of the Whisper element, temperatures of up to 79.2 °C occurred (see Fig. 20 in the attachment).

Fig. 9: Condition of the old, perforated Whisper® NBO-40-A3 absorber element after 10 theoretical years

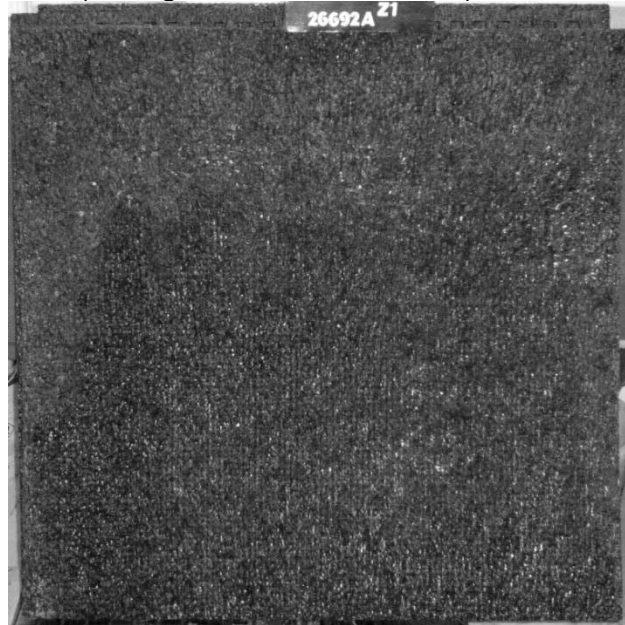
The newly inserted element was deformed due to the variation in thermal stress after 10 theoretical years. Especially in the lower area, there are signs of salt residue left behind during evaporation. The element has gained 0.2 kg in moisture/salt. See also Fig. 10, as well as Tab. 4 and Tab. 5. The temperature profile for the new element for the simulated years 0-10 is shown in Fig. 21 in the

attachment. According to the thermocouple, temperatures of up to 84.8 °C occurred near the surface of the Whisper element (see Fig. 21 in the attachment).

Fig. 10: Condition of the new, perforated Whisper® NBO-40-A3 absorber element after 10 theoretical years

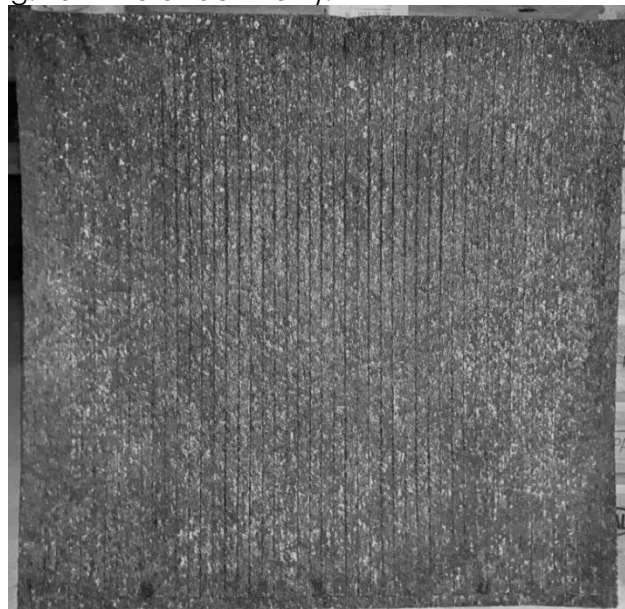
The thermally caused deformation of the element was partially corrected using more fastening points. There are signs of salt residue left behind during evaporation on nearly the entire surface, but especially concentrated in the lower area. The element gained 0.1 kg in moisture/salt. See also Fig. 11, as well as Tab. 4 and Tab. 5. The temperature profile for the simulated years 20-30 is shown in Fig. 23 in the attachment. According to the thermocouple, Whisper element surface temperatures of up to 80.1 °C occurred (see Fig. 23 in the attachment).

Fig. 11: Condition of the milled Whisper® NBO-40-A3 absorber element after 30 theoretical years

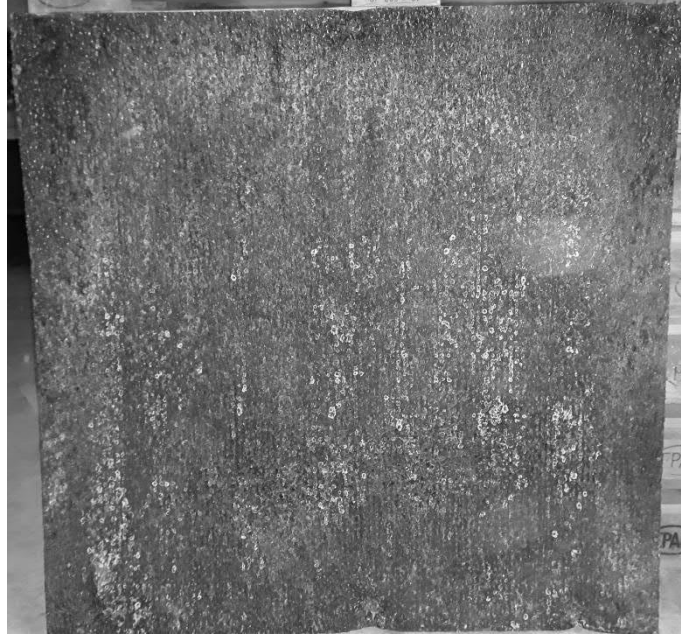
Due to the not completely homogeneous light irradiation and despite the changed switch-on times, there are slight signs of overheating in the lower third. After consulting with the client, it was decided to continue to age this element despite the signs of overheating. There are signs of salt residue left behind during evaporation on nearly the entire surface of the element, but especially concentrated in the lower area. The element gained 0.1 kg in moisture/salt. See also Fig. 12 and Fig. 13 as well as

Tab. 4 and Tab. 5. The temperature profile for the simulated years 20-30 is shown in Fig. 23 in the attachment. According to the thermocouple (positioned in the hot spot; near the surface, approx. 1/3 of the way from the bottom and approx. 1/3 from the right edge), temperatures of up to 80.1 °C occurred in the Whisper element (see Fig. 23 in the attachment).

Fig. 12: Condition of the perforated Whisper® NBO-40-A3 absorber element after 30 theoretical years;

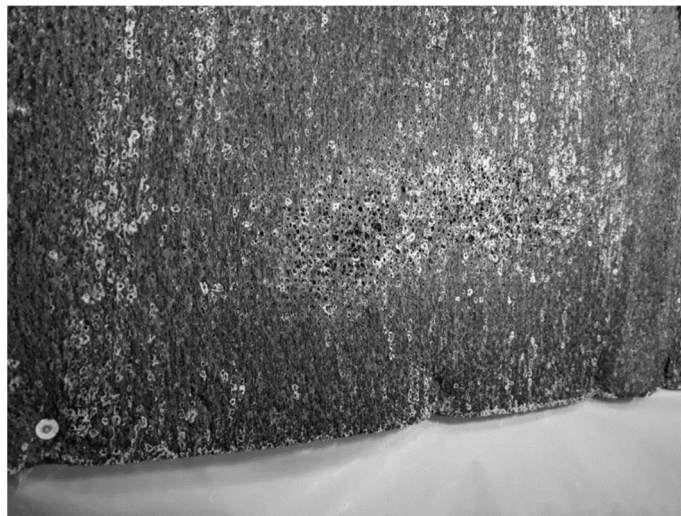
Fig. 13: Condition of the perforated Whisper® NBO-40-A3 absorber element after 30 theoretical years; details of the scorched surface

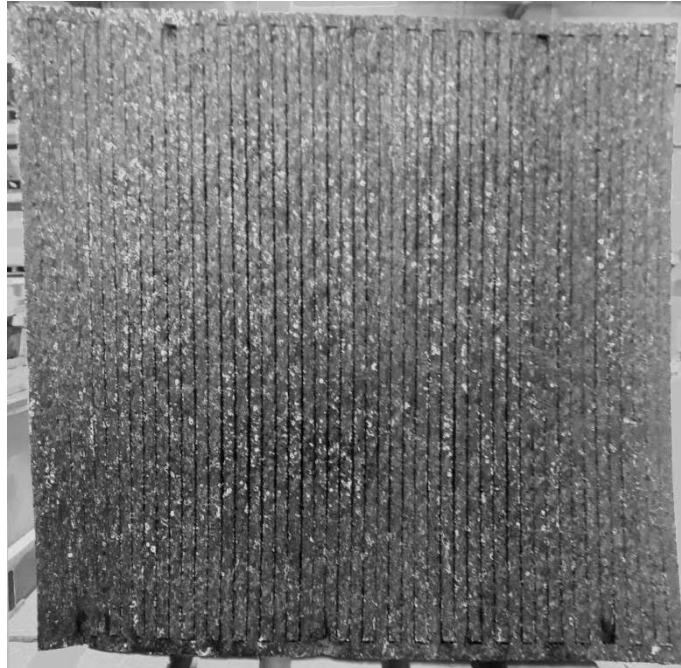
Compared to the previous cycle, the milling trajectories have widened. The element does not show any other obvious changes, however. The element has gained 0.6 kg in moisture/salt. See also Fig. 14, as well as Tab. 4 and Tab. 5. The temperature profile for the simulated years 30-40 is shown in Fig. 24 in the attachment. According to the thermocouple, Whisper element surface temperatures of up to 88.4 °C occurred (see Fig. 24 in the attachment).

Fig. 14: Condition of the milled Whisper® NBO-40-A3 absorber element after 40 theoretical years

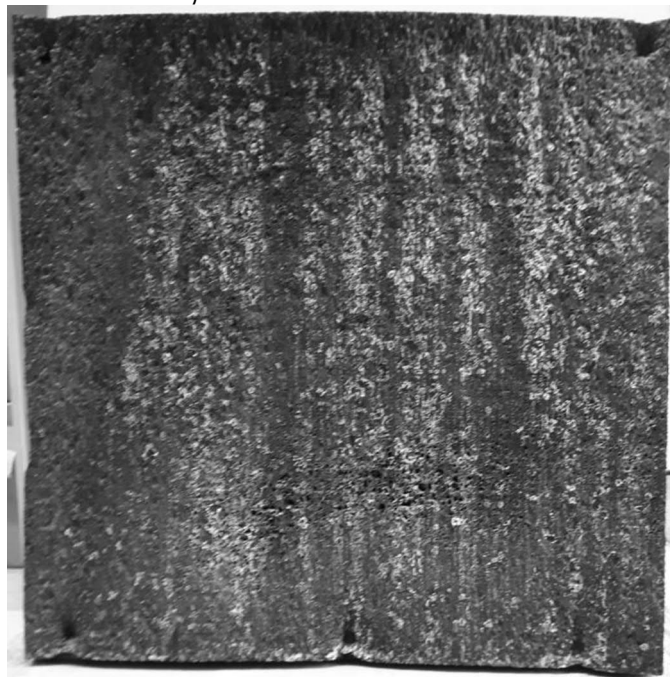
Except for a thicker crust of salt residue, no obvious changes compared to the previous cycle are noticeable. The element gained 0.1 kg in moisture/salt. See also Fig. 15, as well as Tab. 4 and Tab. 5. The temperature profile for the simulated years 30-40 is shown in Fig. 24 in the attachment. According to the thermocouple (positioned in the hot spot; Near the surface, approx. 1/3 of the way from the bottom and approx. 1/3 from the right edge), temperatures of up to 88.4 °C occurred in the Whisper element (see Fig. 24 in the attachment).

Fig. 15: Condition of the perforated Whisper® NBO-40-A3 absorber element after 40 theoretical years

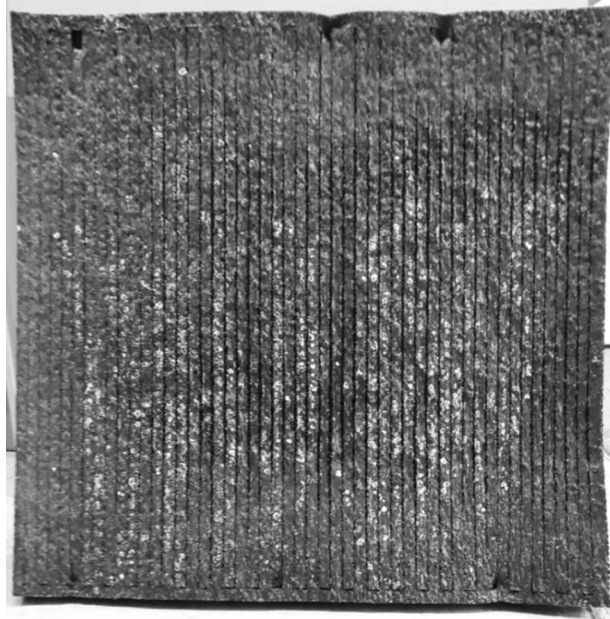
Compared to the previous cycle, the milling trajectories have widened and the thermally caused deformations have worsened. In addition, there was more salt residue on the surface. The element gained 0.3 kg in moisture/salt. See also Fig. 16, as well as Tab. 4 and Tab. 5. The temperature profile

for the simulated years 40-50 is shown in Fig. 25 in the attachment. According to the thermocouple, Whisper element surface temperatures of up to 82.3 °C occurred (see Fig. 25 in the attachment).

Fig. 16: Condition of the milled Whisper® NBO-40-A3 absorber element after 50 theoretical years

The tests have shown that the surface optically changes from matte to glossy as a result of superficial overheating. If overheating continues, the milling trajectories widen and, as a further consequence, signs of melting appear on the surface. This occurs at temperatures of 111 °C (see also BTI report 26692-B1/2020).

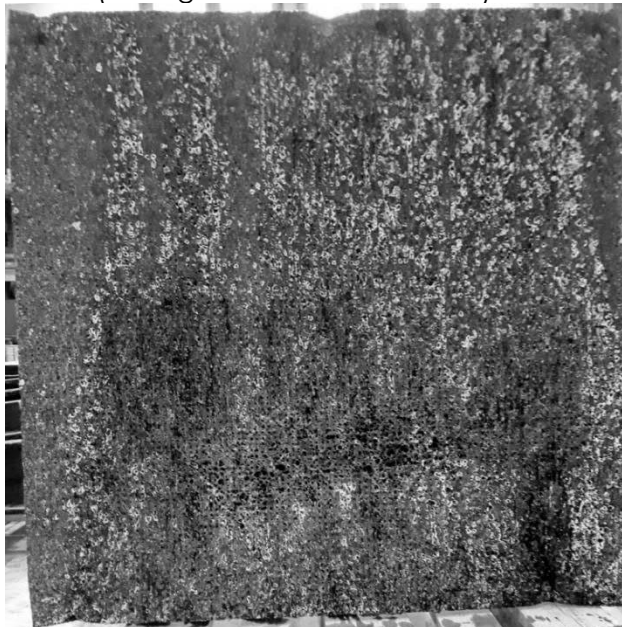
Stronger signs of surface overheating are noticeable than after the previous cycle, and the amount of salt residue has increased. The element has gained 0.2 kg in moisture/salt. See also Fig. 17, as well as Tab. 4 and Tab. 5. The temperature profile for the simulated years 40-50 is shown in Fig. 25 in the attachment. According to the thermocouple (positioned in the hot spot; near the surface, approx. 1/3 of the way from the bottom and approx. 1/3 from the right edge), temperatures of up to 82.3 °C occurred in the Whisper element (see Fig. 25 in the attachment).

Fig. 17: Condition of the perforated Whisper® NBO-40-A3 absorber element after 50 theoretical years

The perforated Whisper plates showed a very similar behaviour to the milled ones, with one difference being that the signs of melting were not as apparent. Surface temperatures higher than 100 °C are to be avoided.

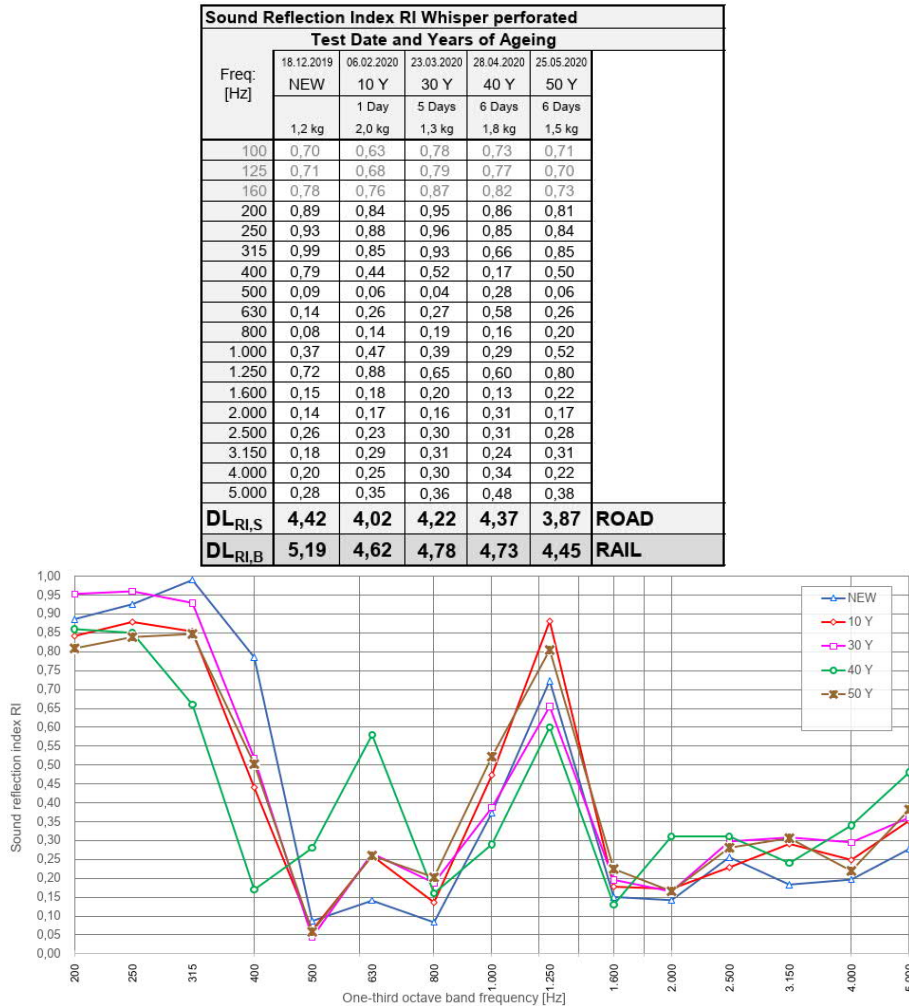
Tab. 6: Results of the noise reflection measurements of the perforated Whisper® NBO-40-A3 absorber with specification of the drying time before the acoustical measurement and the Whisper plate weight in kg (in column headings) over the 50 simulated years

Fig. 18: Results of the noise reflection measurements of the perforated Whisper® NBO-40-A3 absorber

The comparison of the measurement results of the different ageing stages is relevant to the overall assessment of the effect of ageing on sound reflection. As the results in Table 2 and Table 3 show, the measured values DL_{RI} for the ageing stages from 0 years to 50 years range between 3.9 dB and 4.8 dB for the street traffic noise spectrum and 4.5 dB to 5.6 dB for the rail traffic noise spectrum.

The measurement results overall show no clear trend which would allow a conclusion to be made about the dependency of absorption on the ageing stage.

Comparing the DL_{RI} values with the weight, and indirectly with the water content / degree of contamination of the absorber surface, as given in Tab. 6 and Tab. 7, a clear trend is apparent, which indicates that the DL_{RI} values decrease with increasing water content, i.e., the sound reflection increases.

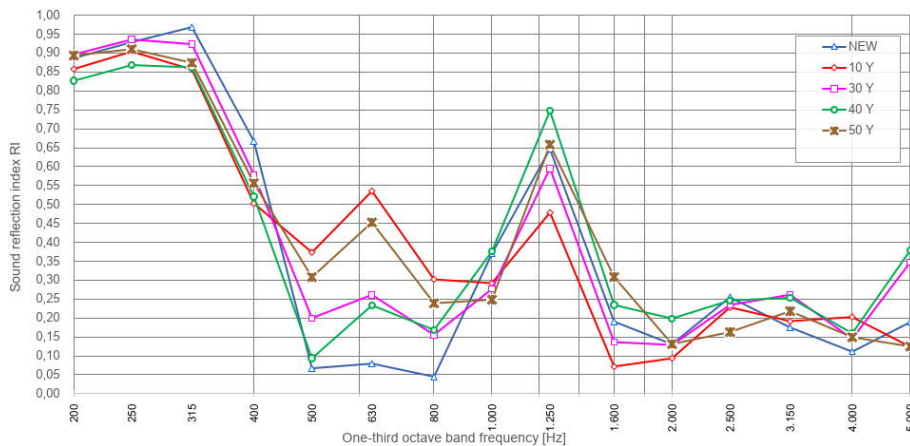
Tab. 7: Results of the noise reflection measurements of the milled Whisper® NBO-40-A3 absorber with specification of the drying time before the acoustical measurement and the Whisper plate weight in kg (in column headings) over the 50 simulated years

Fig. 19: Results of the noise reflection measurements of the milled Whisper® NBO-40-A3 absorber

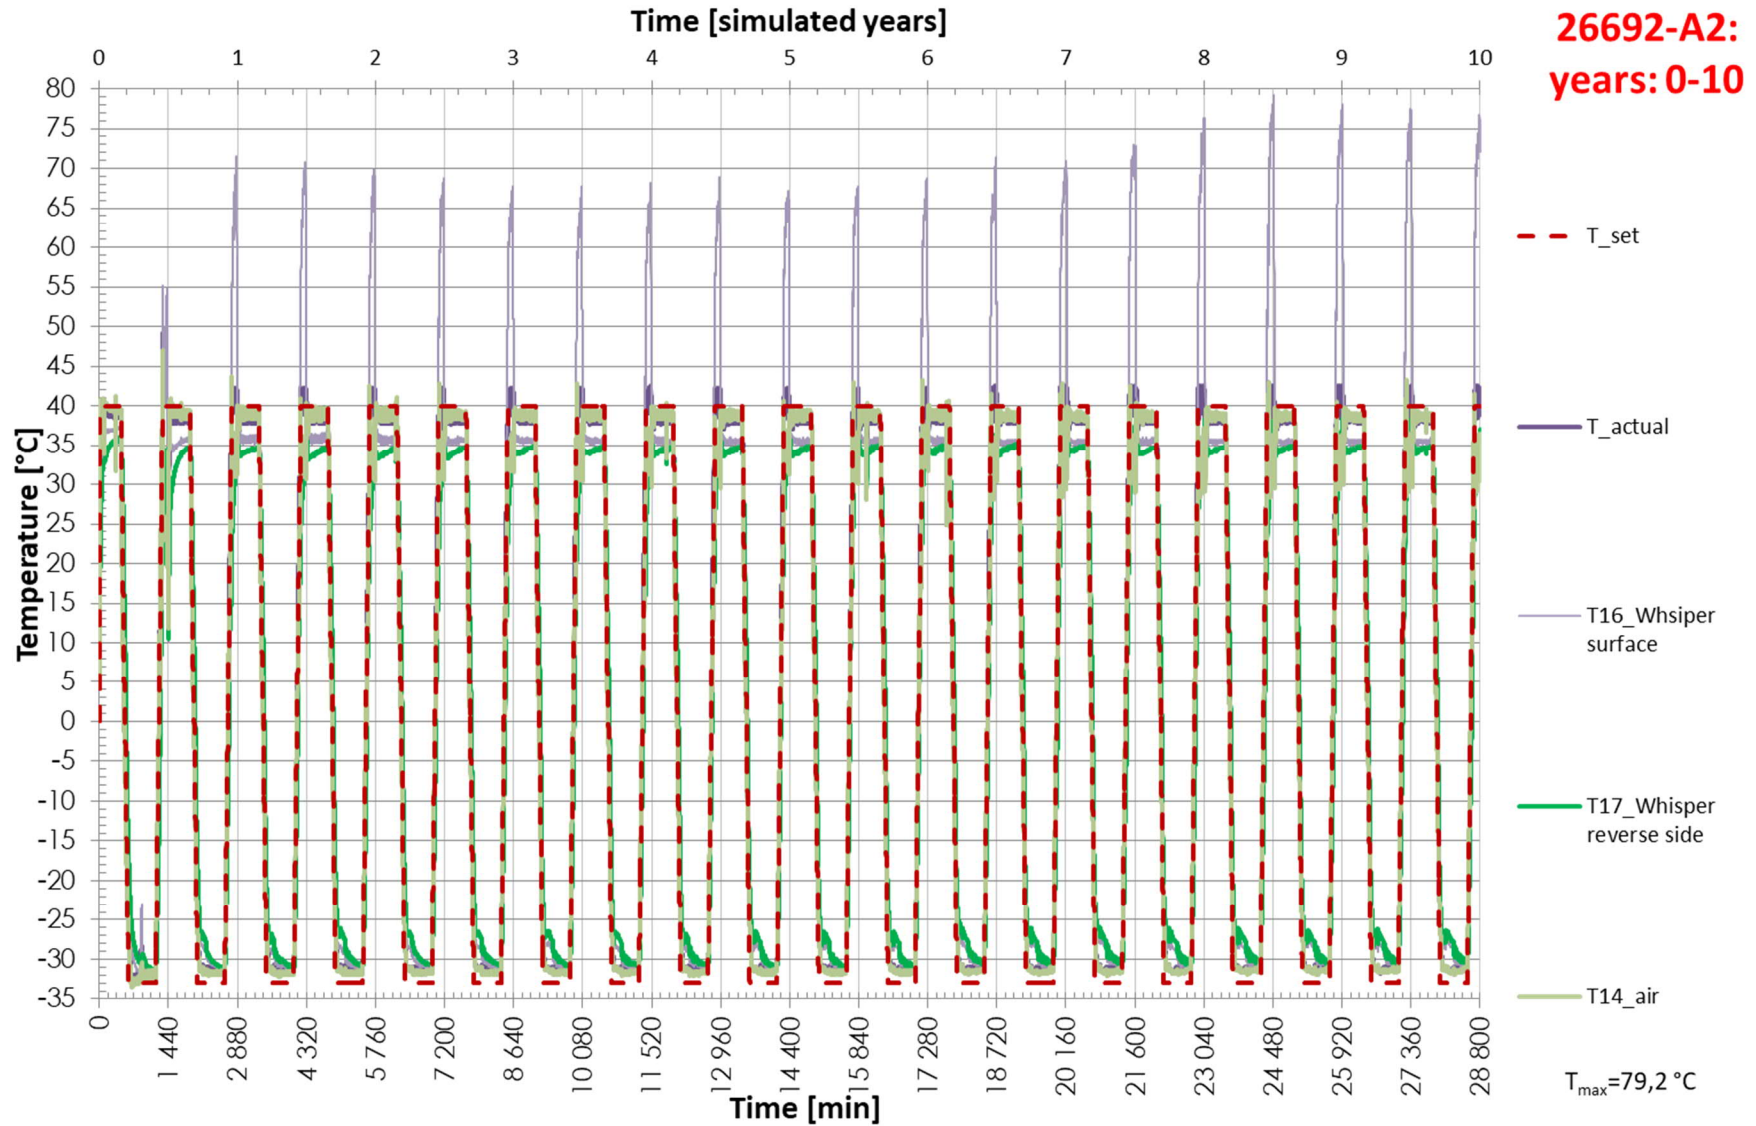
Fig. 20: Temperature profile, recorded using Pt1000 thermocouples which were positioned in the chamber over the first 10 simulated years (old element)

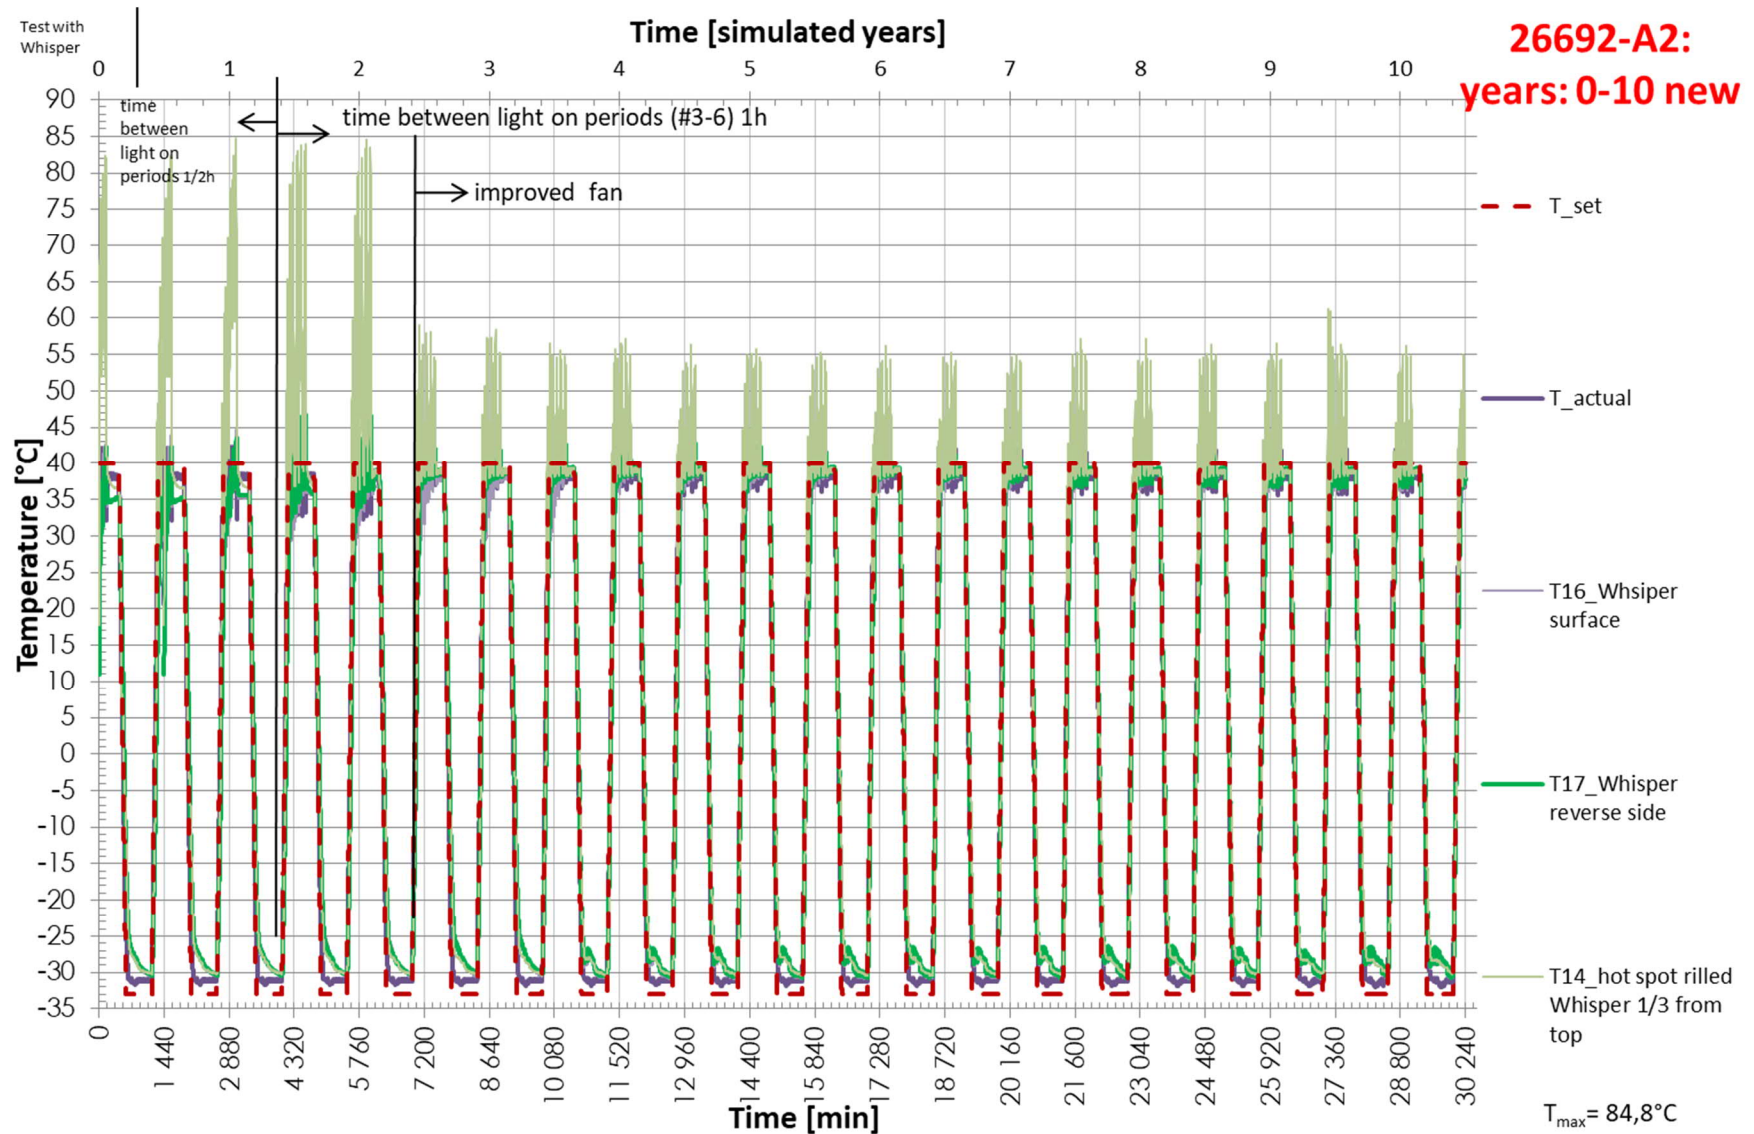
Fig. 21: Temperature profile, recorded using Pt1000 thermocouples which were positioned in the chamber over the first 10 simulated years (new element)

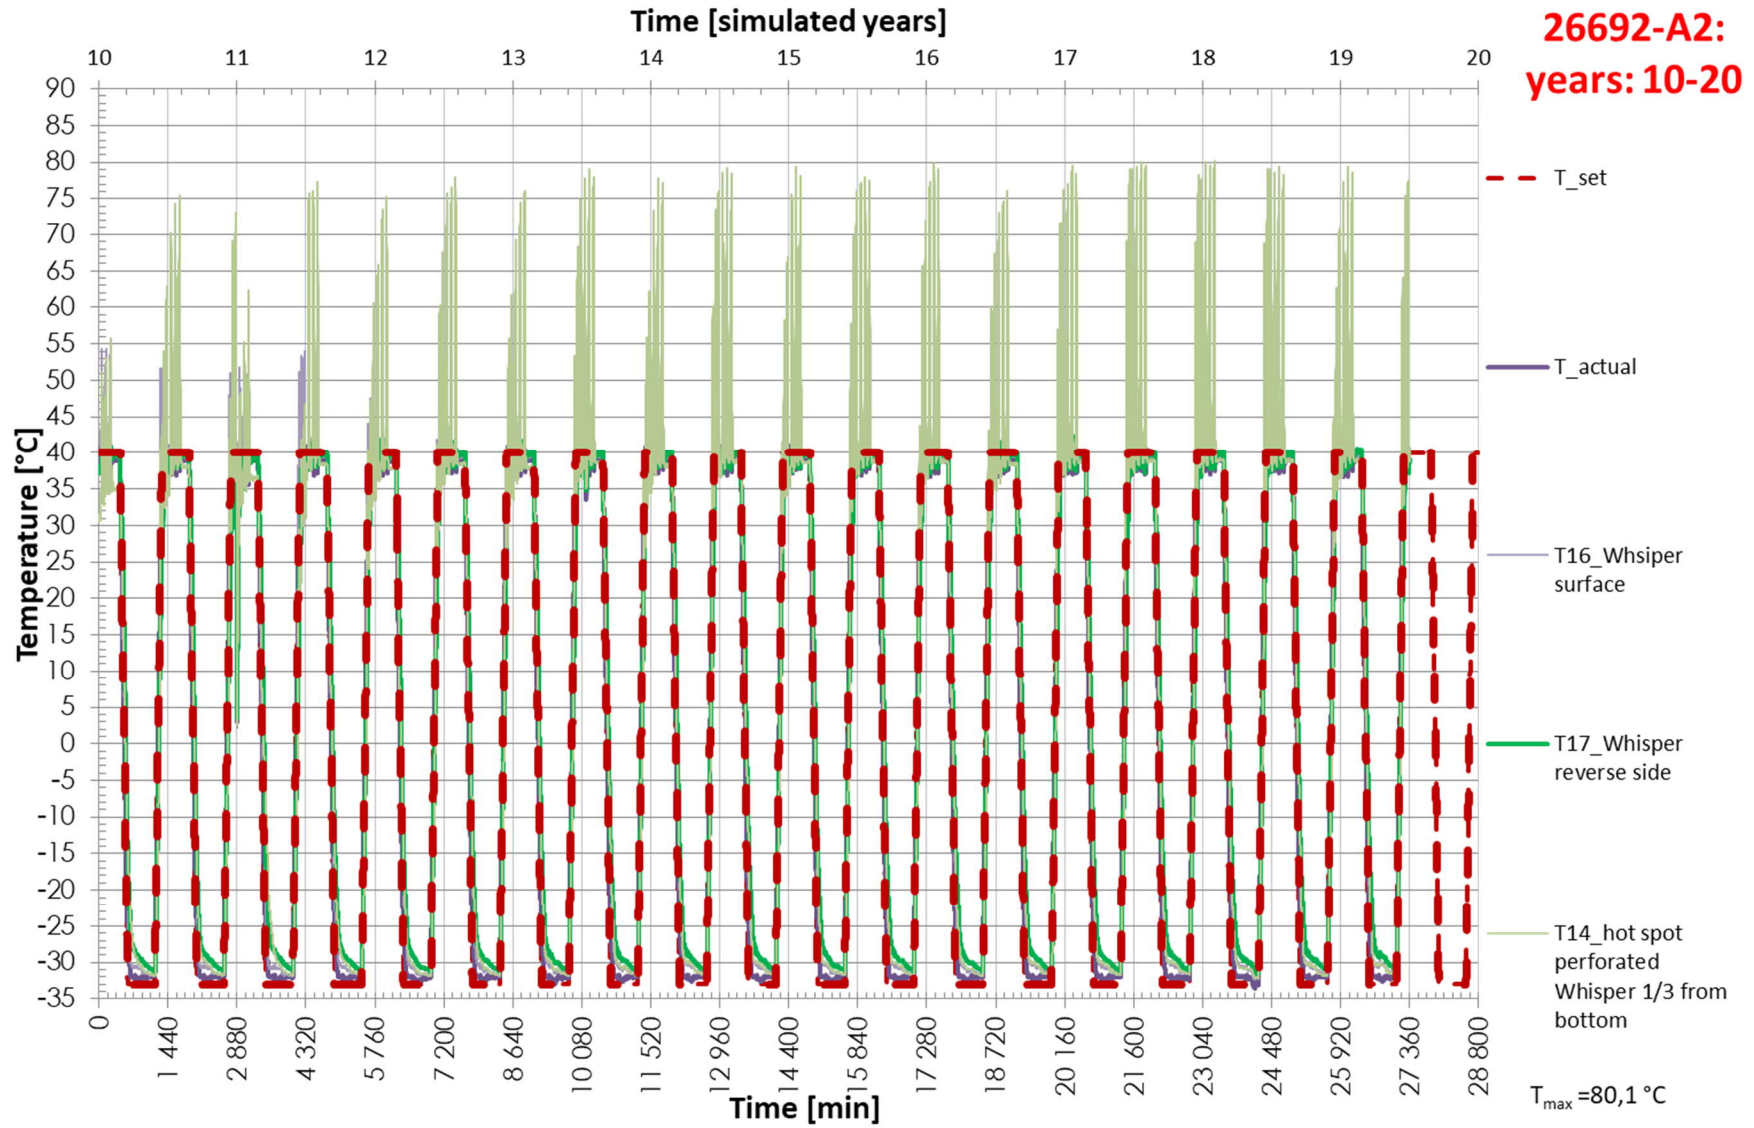
Fig. 22: Temperature profile, recorded using Pt1000 thermocouples which were positioned in the chamber over 10-20 simulated years (new element)

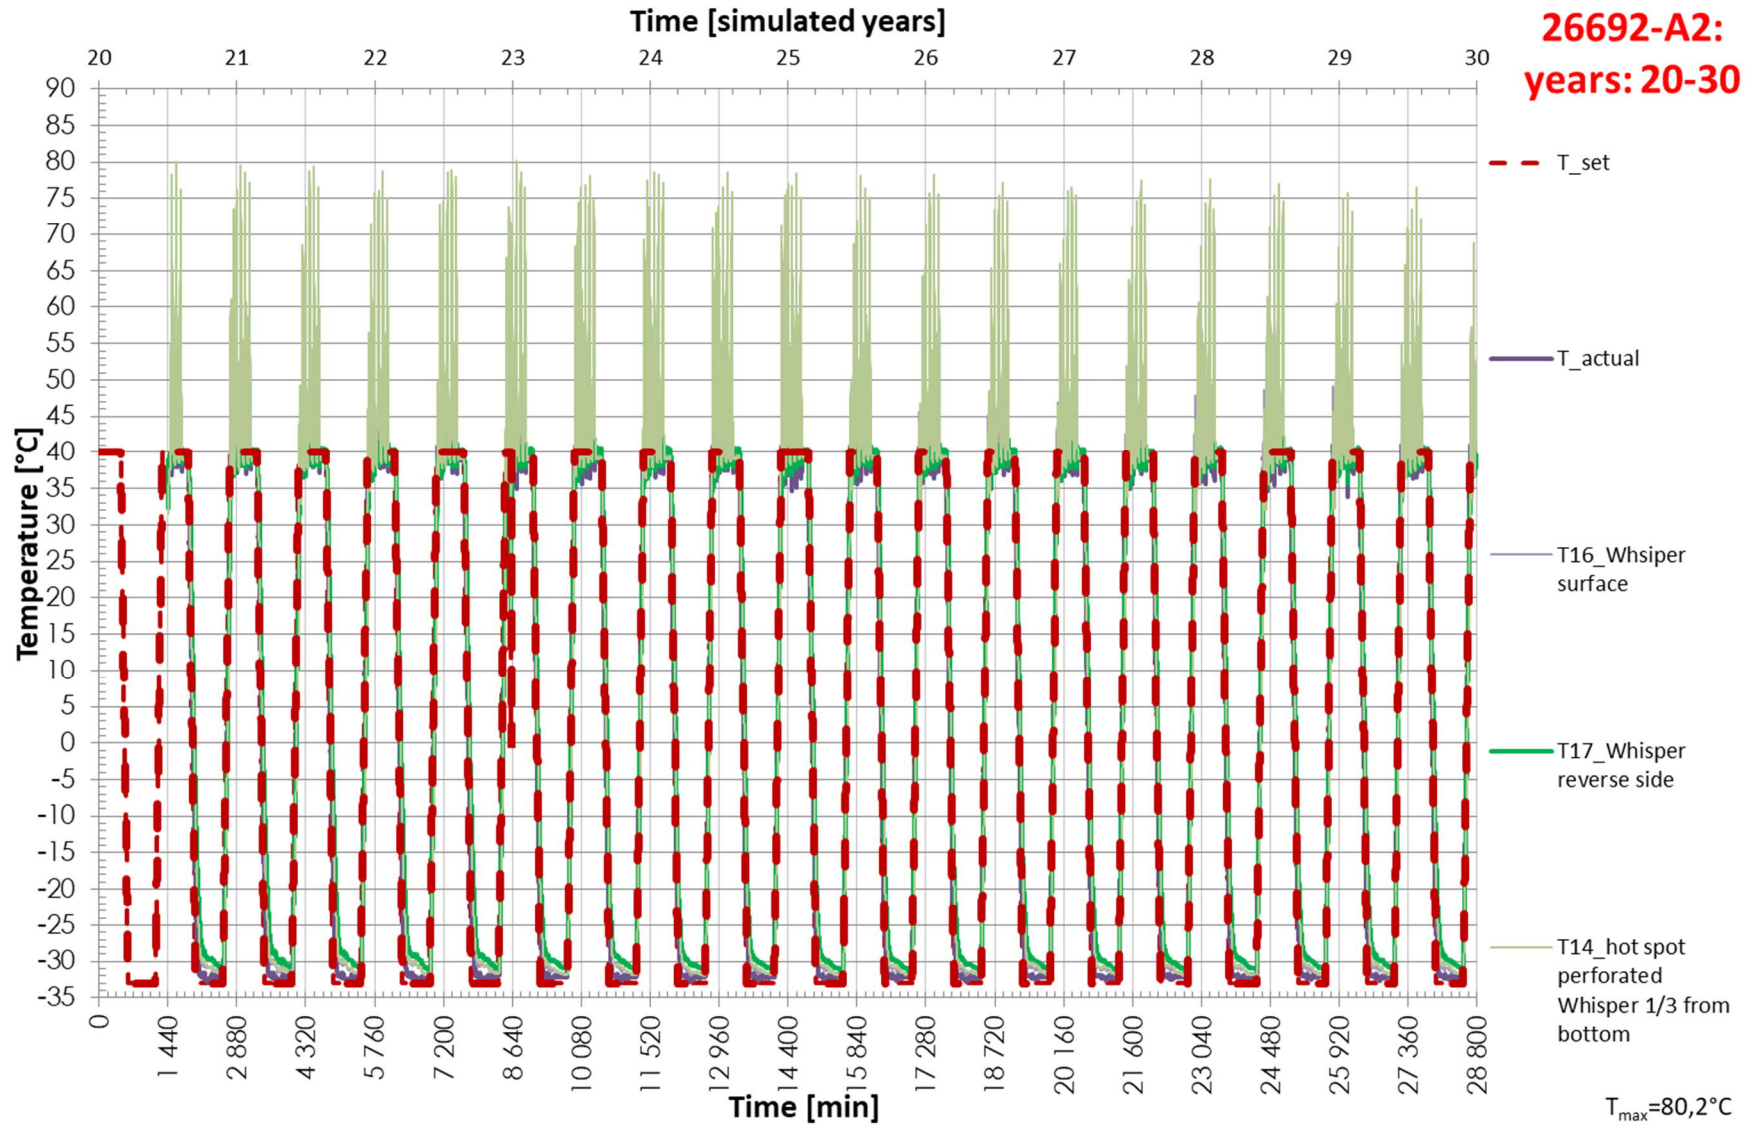
Fig. 23: Temperature profile, recorded using Pt1000 thermocouples which were positioned in the chamber over 20-30 simulated years (new element)

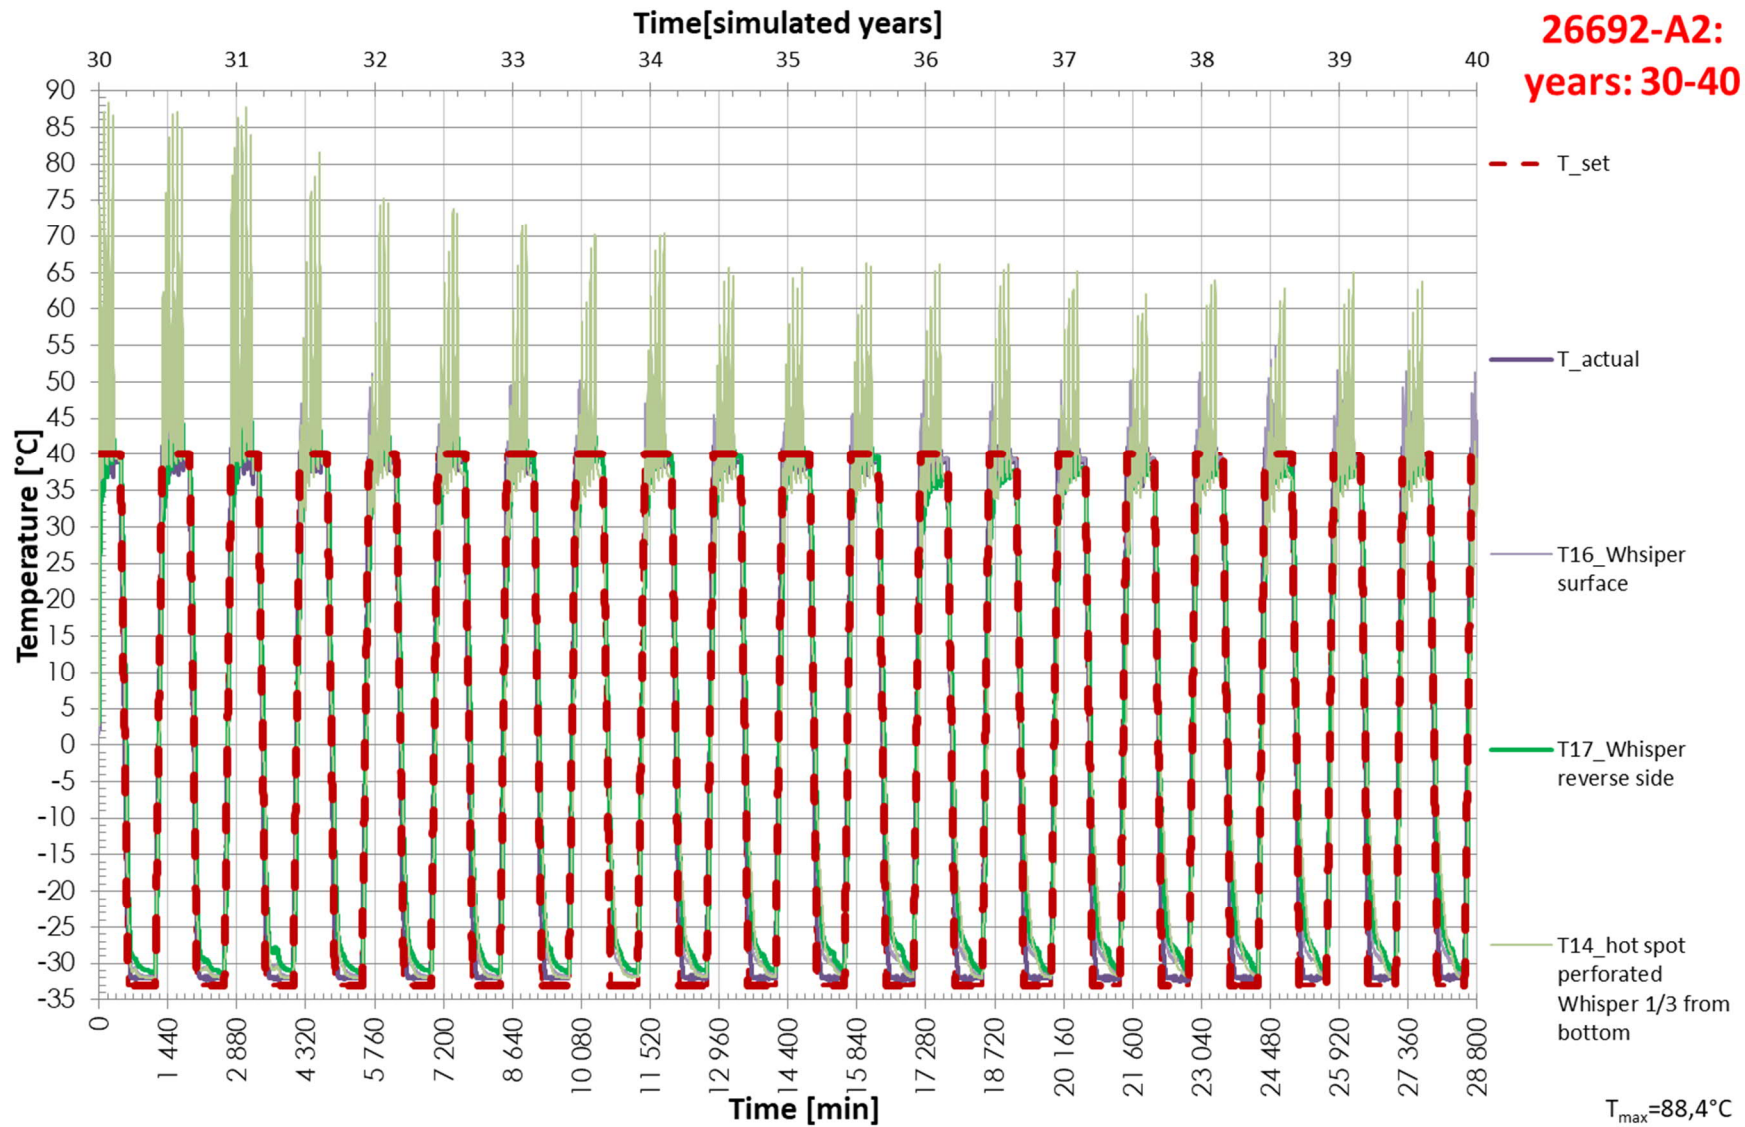
Fig. 24: Temperature profile, recorded using Pt1000 thermocouples which were positioned in the chamber over 30-40 simulated years (new element)
