Test report

BTI number: 26692-A2A/2019

Investigation of the long-term behaviour of **Whisper® NBO-40-A3** noise barrier wall types using time lapse test based on EN 14389-1:2015, EN 14389-2:2015 and EN 60721-3-4:1995 for 50 simulated years.

Sealed Air Verpackungen GmbH

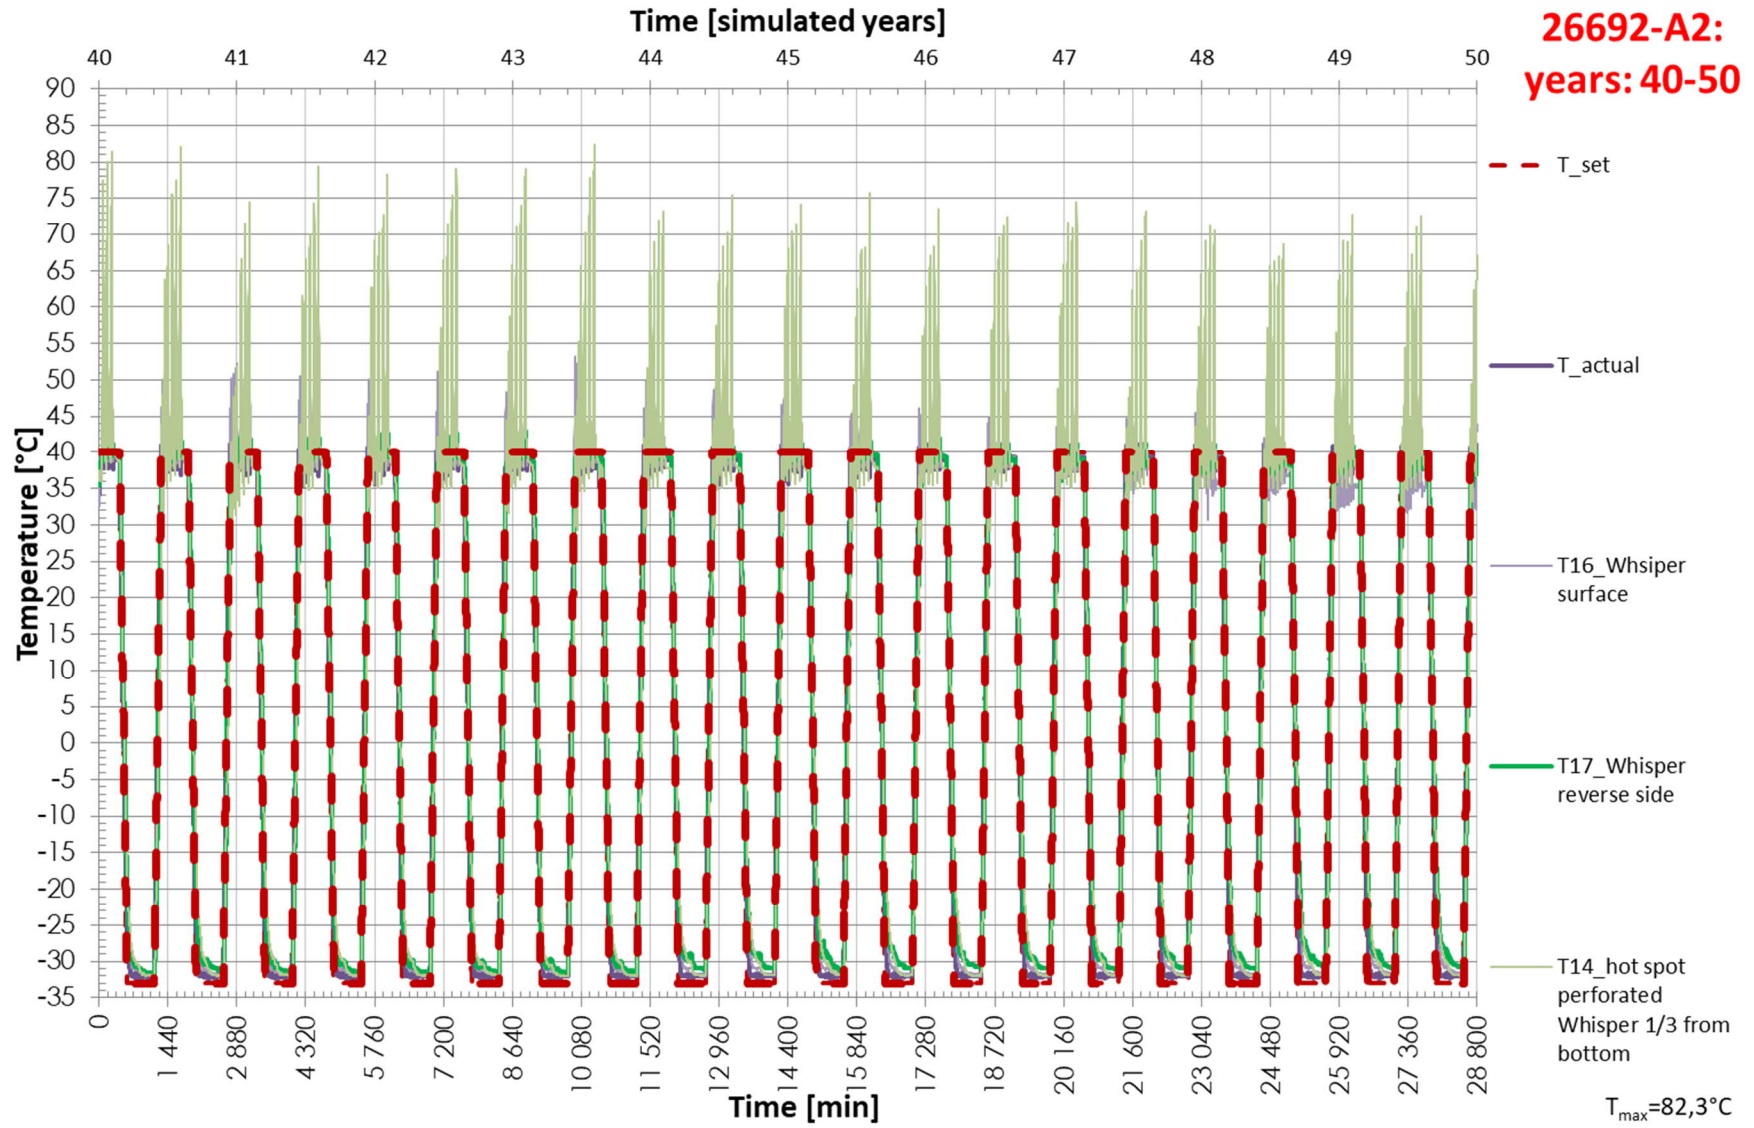
Fig. 25: Temperature profile, recorded using Pt1000 thermocouples which were positioned in the chamber over 40-50 simulated years (new element)

for the simulated years 40-50 is shown in Fig. 25 in the attachment. According to the thermocouple, Whisper element surface temperatures of up to 82.3 °C occurred (see Fig. 25 in the attachment).

Stronger signs of surface overheating are noticeable than after the previous cycle, and the amount of salt residue has increased. The element has gained 0.2 kg in moisture/salt. See also Fig. 17, as well as Tab. 4 and Tab. 5. The temperature profile for the simulated years 40-50 is shown in Fig. 25 in the attachment. According to the thermocouple (positioned in the hot spot; near the surface, approx. 1/3 of the way from the bottom and approx. 1/3 from the right edge), temperatures of up to 82.3 °C occurred in the Whisper element (see Fig. 25 in the attachment).
